CHARLES RIVER DAM AT SOUTH NATICK

PHASE I INSPECTION/EVALUATION REPORT

Dam Name: Charles River Dam at South Natick

Date of Inspection: October 13, 2017

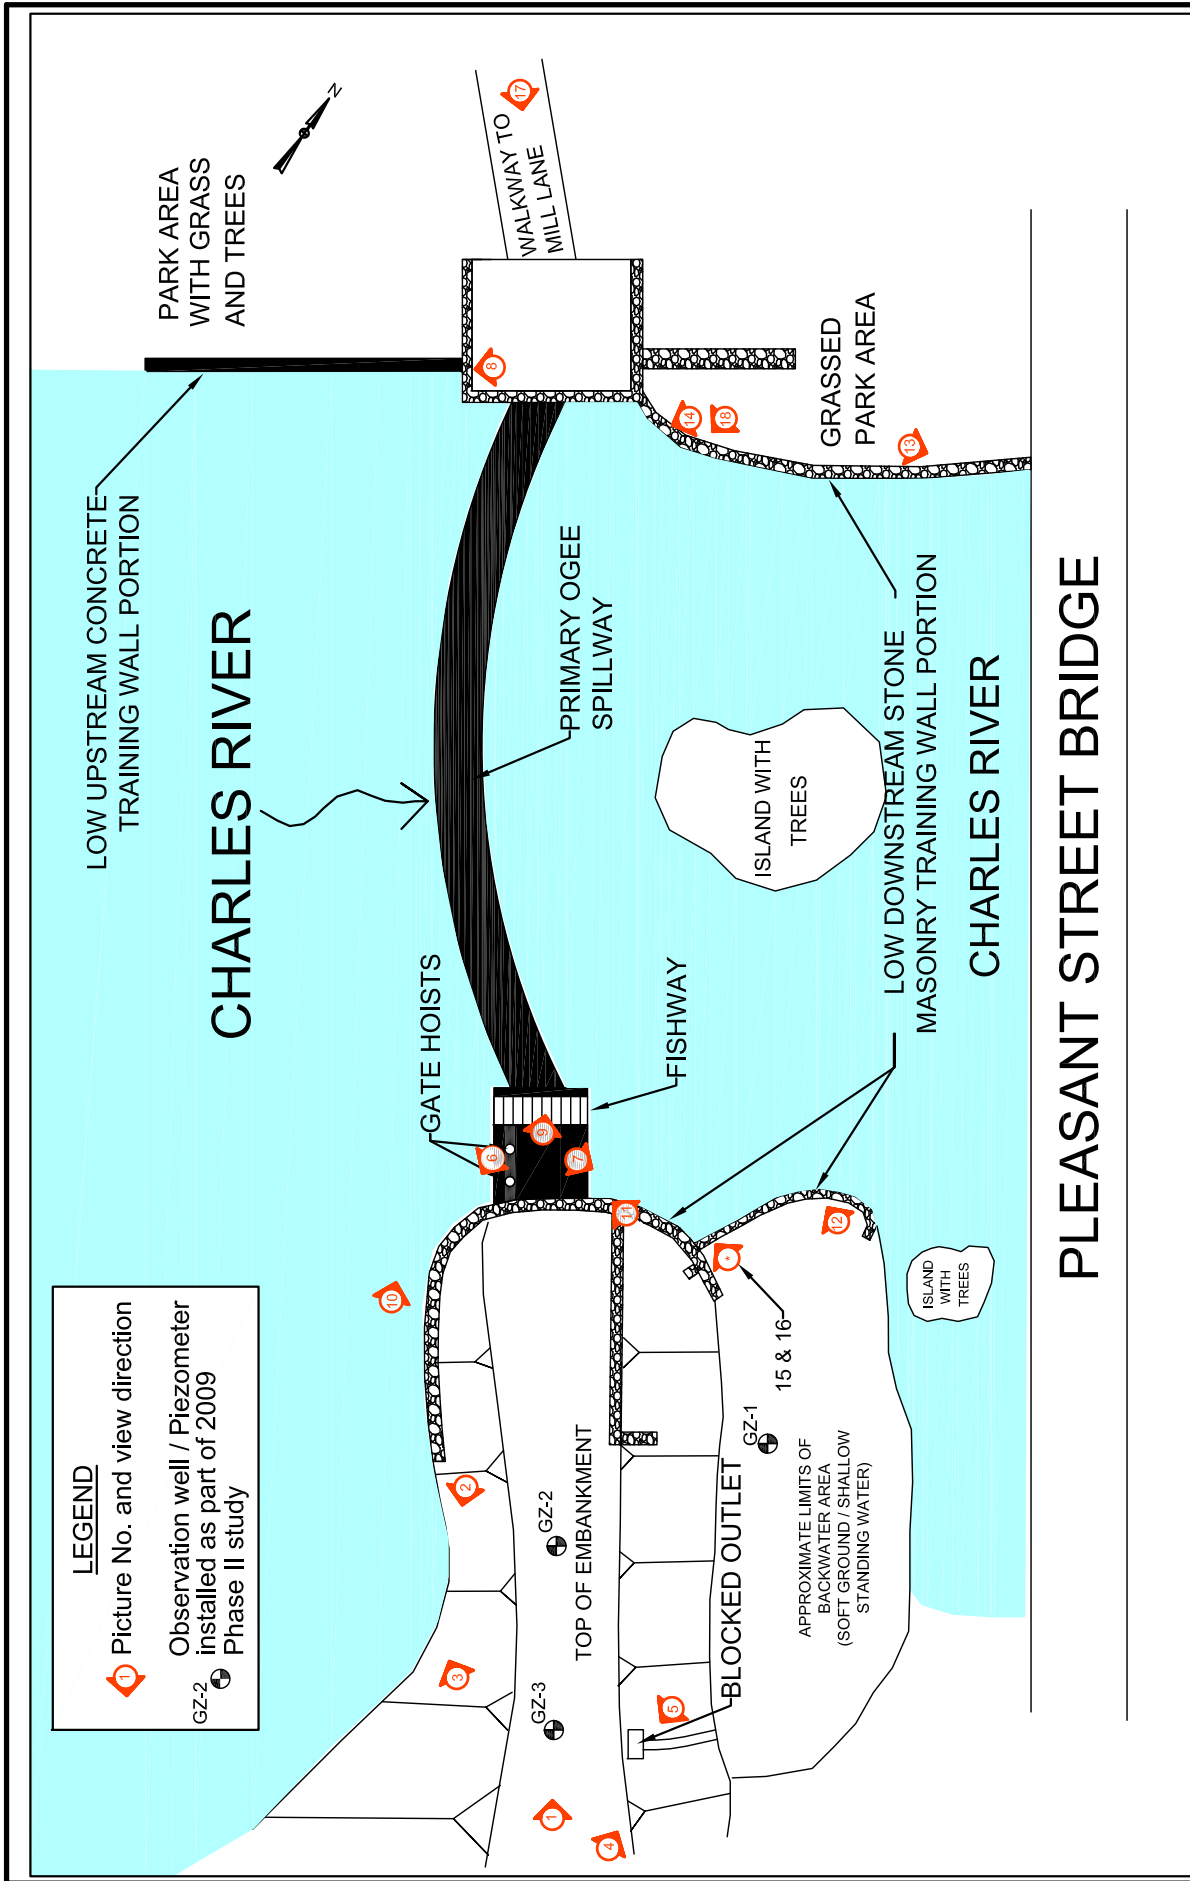
As part of the 2009 Phase II study an exploration program consisting of four (4) test borings were drilled to aid in the analyses. Observation wells and open standpipe piezometers were placed in three of the borings. Refer to **Figure 5** for approximately locations. Water level readings were taken at each well/piezometer during this inspection and are reported in the Inspection Checklist. It should be noted that the piezometric water surface elevation in the piezometer in GZ-2 was approximately 2.4 feet higher than the phreatic surface water elevation recorded in the observation well in this same borehole. This observance is indicative that little upward flow is present within the embankment at this location and supports our 2009 seepage/stability analysis which judged the embankment as having acceptable factor of safety values.
